I-5 Skagit River Bridge Collapse Review

Abstract: On May 23, 2013, a truck-tractor with a flatbed semitrailer hauling an oversized container was traveling south on Interstate 5 (I-5) near Mount Vernon, Washington. While crossing the Skagit River, the oversized container struck portions of the through-truss bridge, which resulted in a 49-m (160-ft) simple-span section of the 339-m (1,112-ft) bridge collapsing into the river. This collapse occurred even though the oversized container had a permit authorizing the travel route and was being escorted by a pilot vehicle. This paper (1) identifies some key transportation issues related to this scenario, e.g., permitting, route databases, signage, buffer between posted and actual clearance, insurance coverage, and pilot car requirements/operation; and (2) presents a structural analysis of the impact that provides insight into the truss design, damage sequence, failure mode, and potential techniques to increase the robustness of this class of bridge. DOI: 10.1061/(ASCE)CF.1943-5509.0000913. © 2016 American Society of Civil Engineers.

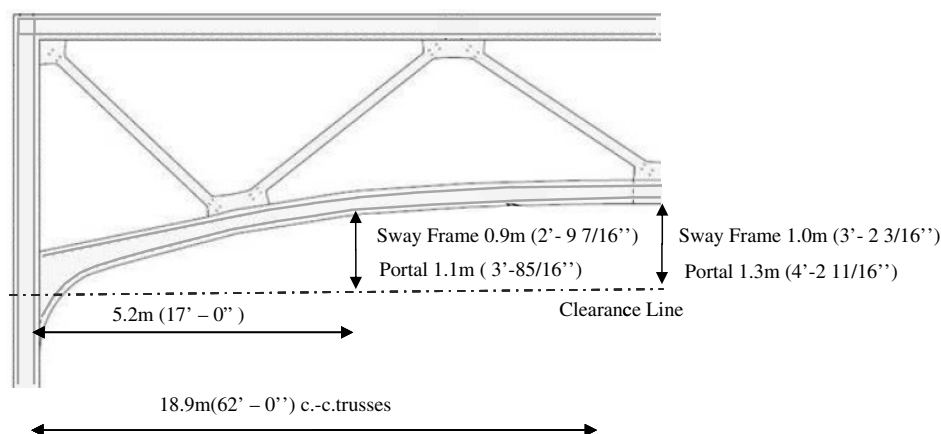
Fig. 5. Elevation of first sway frame on the I-5 Skagit River Bridge

In addition to variable vertical clearance across the portal frame, variable vertical clearance also existed along the I-5 Skagit River Bridge. The vertical clearance at the entrance arch (portal frame in Fig. 4) is higher than the vertical clearance at the first interior arch (first sway frame), which is shown in Fig. 5. As will be discussed later, the bridge collapse initiated when the first sway frame was impacted by the oversized container. Fig. 5 shows a sway frame that is typical for Spans 5, 6, 7, and 8 of the bridge inboard from the portal shown in Fig. 4. The sway frame has significantly lower vertical clearance over the travel lanes than does the portal frame because the sway frame has a flatter curvature than the portal frame. For example, the sway frame has a vertical clearance of only 0.9 m (2.95 ft) above the clearance line (Fig. 5), while the portal frame has a maximum vertical clearance of 1.1 m (3.31 ft) above the clearance line (Figs. 4 or 5). The permitting and signage for this bridge were based on the vertical clearance of the portal frame and not the sway frame, which is unfortunately the limiting case. In summary, the signage should reflect the variable and minimum vertical clearance and not only the portal entrance clearance.

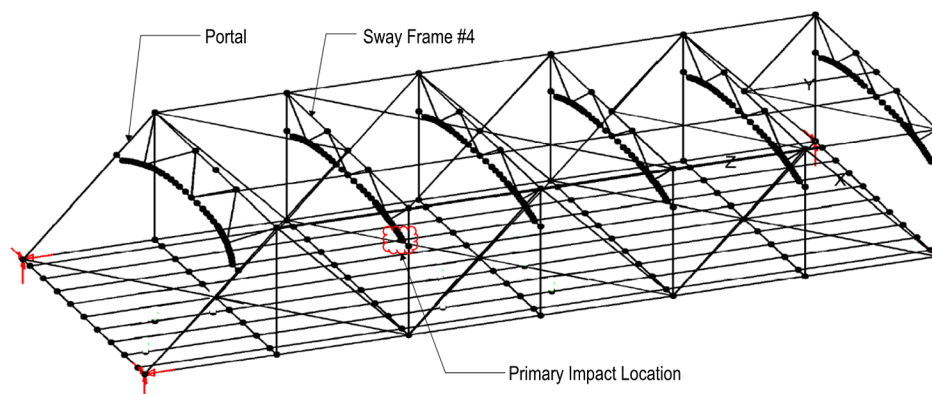
Fig. 9. Three-dimensional numerical model of Span 8

Sway frame members and longitudinal stringers were modeled with pinned ends due to the relatively flexible connections that were employed. The riveted-steel connections between main truss members were assigned to be rigid based on the connection depths and their ability to transmit significant bending moments. Support conditions at both ends of the 3D model are the same as those applied in the 2D model and are shown in Fig. 9.

The 2D and 3D numerical models were validated by comparing truss member forces obtained from the models to those reported on the engineering design drawings. The total reaction forces at the pier supports obtained using the 2D and 3D models are within 1% of the design drawing values. In addition, truss member forces obtained from the 2D model are in agreement with the design drawings, with a maximum difference of 3%. In the 3D model, the axial forces in the majority of the members are consistent with the engineering design values but small differences (less than 7%) appear in the bottom and top chords because lateral bracing systems on the top and bottom planes of the through truss take some modest tension or compression force from the truss chords.

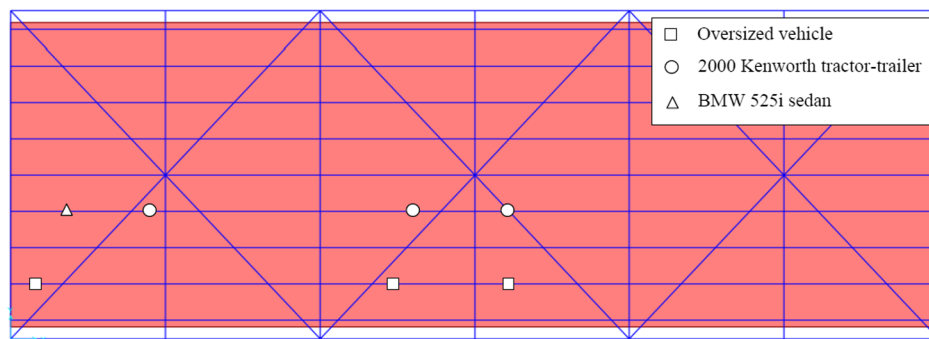
Fig. 10. Plan view of Span 8 showing location of vehicles at time of impact

The overall loading condition of the collapsed truss span was estimated from the design drawings and the NTSB accident report (NTSB 2014). Vehicle live load was estimated at the time of collapse, and the dead load, which included superimposed dead load (SDL) and the weight of the steel structure and concrete slab, was estimated after initial construction and at the time of collapse (considering the previously described bridge modifications over time). The total dead load of Span 8 after original construction was estimated to comprise (1) self-weight of structural steel and concrete slab [5,640 kN (1,268 kips)], (2) SDL weight of the original rail posts and curbs [417 kN (93.7 kips)], and (3) an additional estimated overall SDL [246 kN (55.2 kips)], which corresponds to 287 N/m² (6 psf).
