Seismic Retrofit of Tuttle Creek Dam

Abstract: This paper discusses the seismic retrofit of Tuttle Creek Dam near Manhattan, Kansas, including investigations, seismic analyses, design, construction, and stabilization techniques used. Original plans called for stabilization of the upstream and downstream slopes and installation of an upstream cutoff wall to reduce underseepage. However, constructability and dam safety issues, along with the results of refined seismic deformation analyses, led to cancellation of the jet grouted upstream slope stabilization and cutoff wall. Downstream slope stabilization was to be accomplished by jet grouting or soil mixing, but ultimately was accomplished using a self-hardening cement-bentonite (C-B) slurry to construct transverse shear walls. A total of 351 transverse shear walls were constructed along the downstream toe by primarily clamshell equipment. Typical shear walls are 13.7 m long, 1.2 m wide, and extend 18.9 m deep or about 6.1 m into the coarse foundation sands. The walls are spaced at 4.3 m on center along the downstream toe for a replacement ratio of about 29%. In addition to the transverse shear walls, the relief well collection ditch

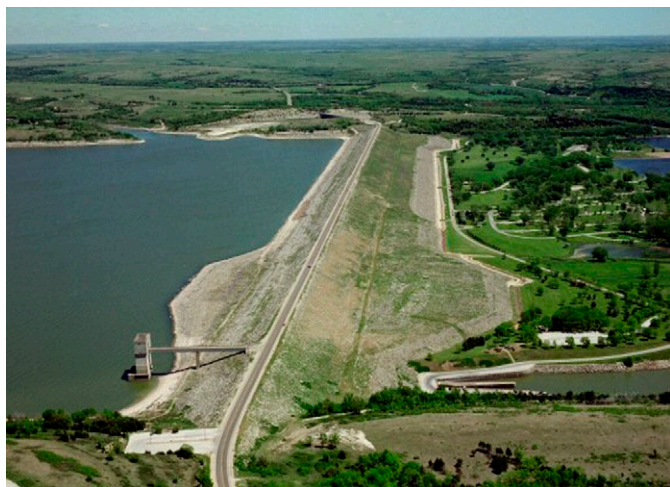
Fig. 1. Aerial view of Tuttle Creek Dam (photo used with permission of U.S. Army Corps of Engineers, Kansas City District)

Tuttle Creek Dam is a U.S. Army Corps of Engineers (USACE) project, located on the Big Blue River in the Kansas River Basin (see Fig. 1). It is part of a system that provides a comprehensive plan for flood control, water supply, and supplemental release for navigation of the Missouri River. Construction started in 1952 and was completed in 1961. Reservoir filling began in 1962 and the multi-purpose pool (MPP) elevation was first reached in 1963. Tuttle Creek Dam is a zoned earthfill embankment (Lane and Fehrman 1960) and is located about 10 km (6 mi) north of Manhattan in east central Kansas. The embankment is 2,300 m (7,500 ft) long and about 43 m (137 ft) high, with a crest width of 15.2 m (50 ft). There is a gated, concrete chute emergency spillway on the left abutment. The 290 m (952 ft) wide spillway structure consists of a concrete gravity section with 6.4 m (21 ft) by 12 m (40 ft) tainter gates, a 183 m (600 ft) long concrete apron and an unlined discharge chute to the

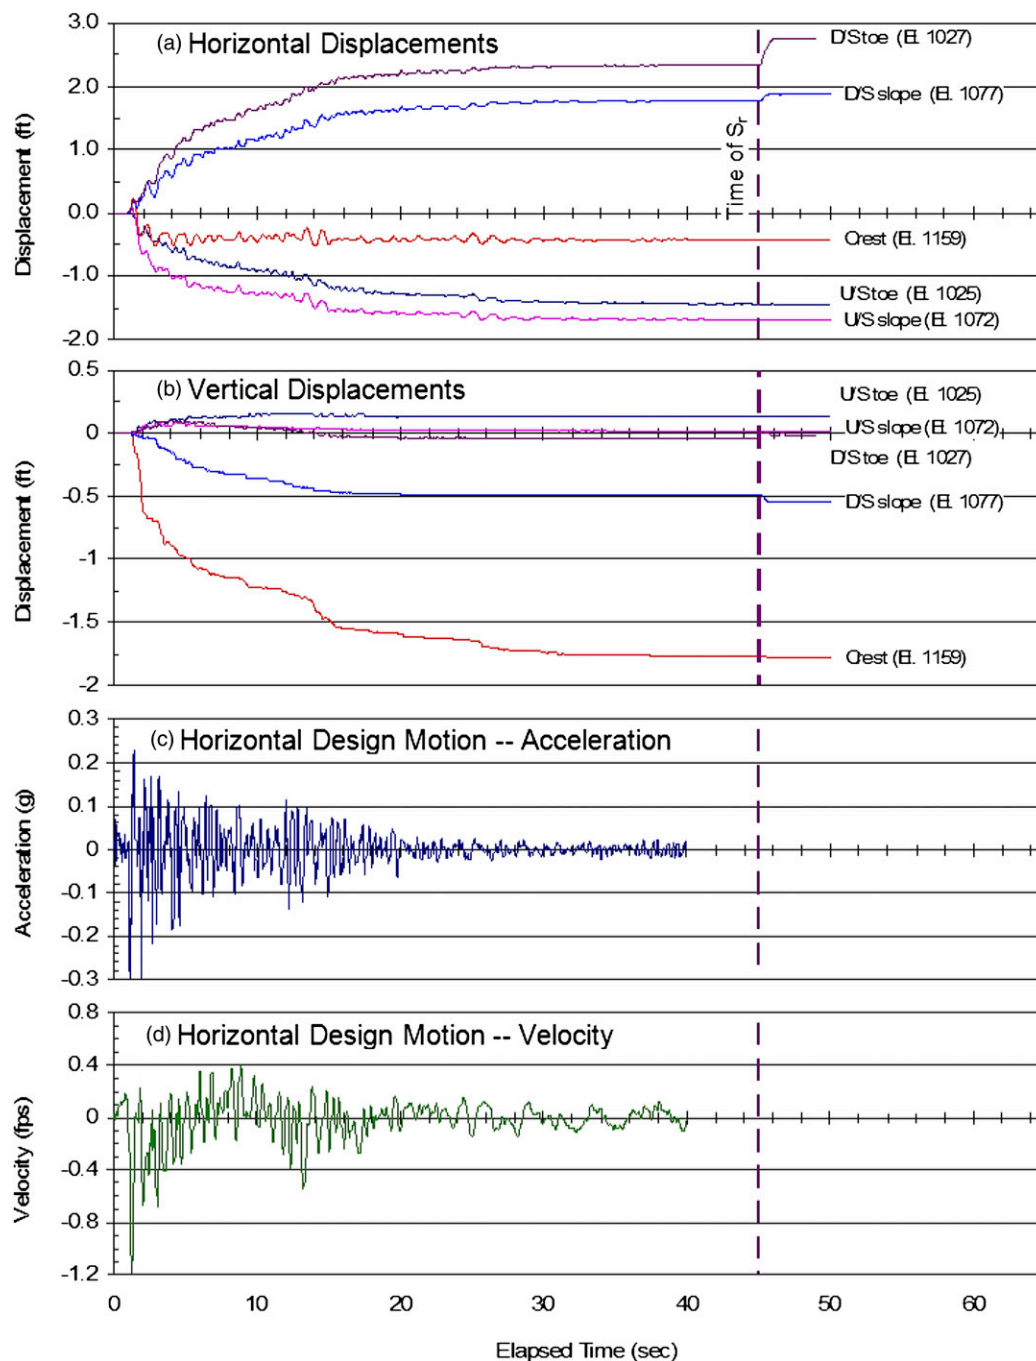
Fig. 6. Time histories of (a) horizontal, (b) vertical, (c) horizontal acceleration design motion, and (d) horizontal velocity design motion

The predicted evolution of permanent vertical and horizontal displacements during the earthquake is shown in Fig. 6 at several locations on the surface of the dam. The horizontal velocity and acceleration design ground motion is initially large and dissipates, while most of the displacement accumulates in a steady and gradual manner over the first 20 s of the design ground motion. The estimated permanent deformations result from limited liquefaction at the upstream toe, extensive liquefaction of foundation sand at the downstream toe, and liquefaction of the fine-grained blanket under the dam (see Fig. 7).
