2 **Under-Tie Pads to Improve Track Resiliency in**
3 **Railroad Transition Zones**

4
5
6 *TRB 17-03313*

8
9 *Transportation Research Board 96th Annual Meeting*

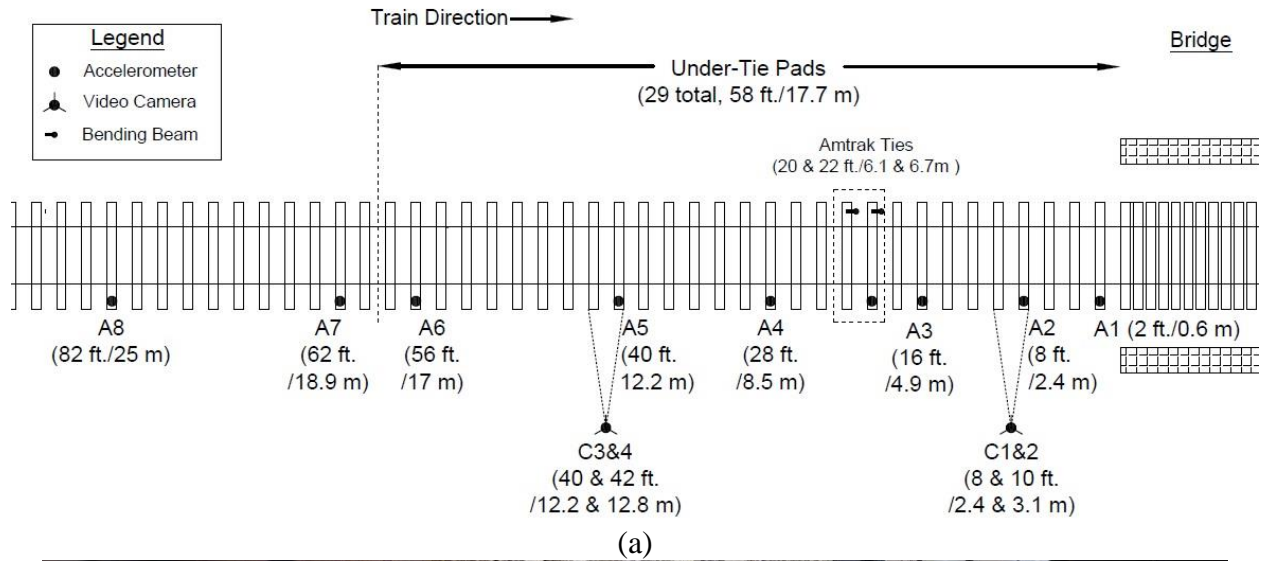
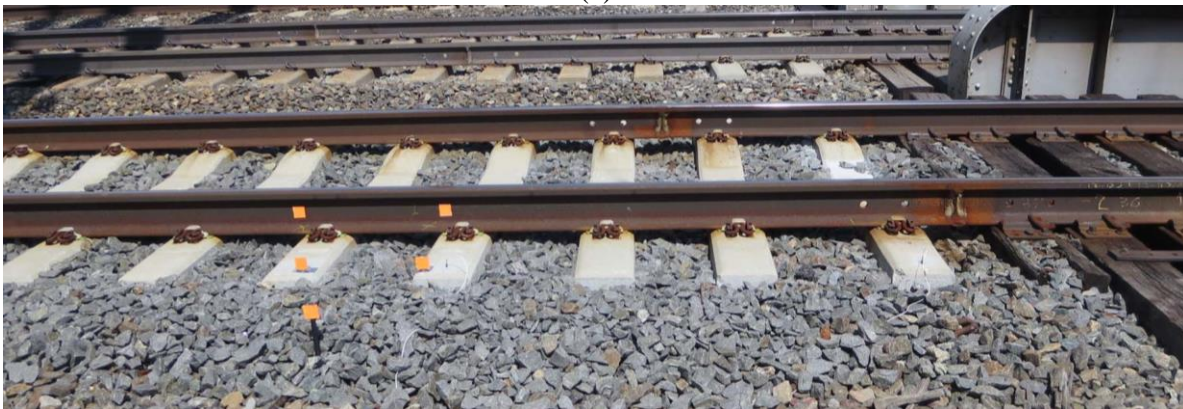
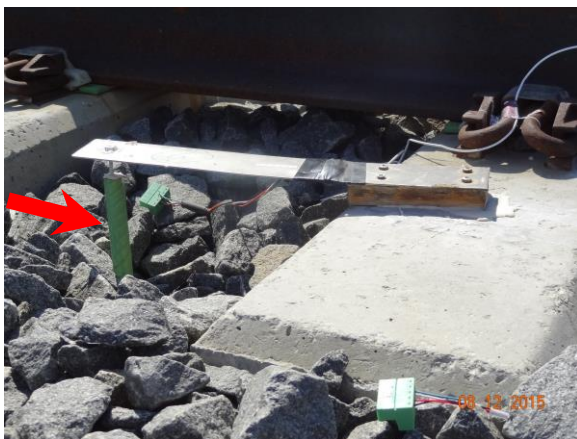
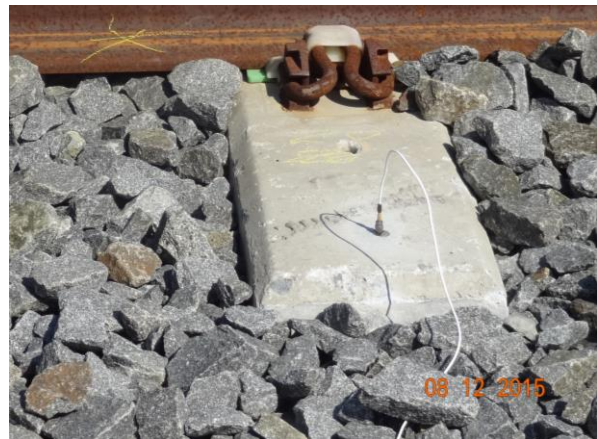
1 **Figure 1: Upland Street northern Track #2 approach with UTPs: (a) diagram showing**
 2 **instrumentation layout, (b) overview photograph of transition with orange**
 3 **targets for video cameras, (c) Bending Beam with reference stake (see arrow)**
 4 **located in crib, and (d) accelerometer attached to a concrete tie.**
 5

16 On 12 August 2015, two instrumentation teams, one from University of Illinois at Urbana-
17 Champaign (UIUC) and the other from Amtrak, installed multiple instruments to evaluate the
18 transient behavior of the southern Track #2 approach of the Upland Street bridge about one year
19 after UTP installation. The instrumentation layout is shown in Figure 1(a). The UIUC team
20 measured tie displacement at Ties #4, #5, #20, and #21 at distances 2.4, 3.1, 12.2, and 12.8
21 meters (8, 10, 40, and 42 ft.), respectively, from the bridge abutment using two high-speed video
22 cameras. To maintain consistency with previous papers at this location, the distance from the
23 bridge abutment is expressed in Imperial units [1,4]. The cameras measure displacements by
24 tracking 50 mm by 50 mm (2x2 inch) orange targets attached to the concrete ties (see Figure
25 1(b)) with imaging software developed at the UIUC [22]. The video cameras collect data at 240

26 frames per second which has been found to be adequate for high-speed passenger traffic by
27 comparing the data with LVDT measurements at the northern Track #3 approach. The Amtrak
28 team measured tie displacements at Ties #10 (6.1 meters/20 feet) and #11 (6.7 meters/22 feet)
29 with an in-house device called a “Bending Beam”, which operates similar to a dynamic
30 voidmeter [23]. The Bending Beam is shown in Figure 1(c) and measures the displacement of the
31 moment arm using calibrated strain gauges to +/-10 mm.

32 Both the UIUC and Amtrak teams also installed accelerometers (Figure 1(d)) to measure
33 tie accelerations and calculate tie displacements using double-integration techniques [22,24]. The
34 UIUC team measured tie accelerations at Ties #1, #4, #8, #14, #20, #28, #31, and #40 at
35 distances 0.6, 2.4, 4.9, 8.5, 12.2, 17.0, 18.9, and 25.0 meters (2, 8, 16, 28, 40, 56, 62, and 82 ft.),
36 respectively, from the bridge abutment using piezo-electric accelerometers. The Amtrak team
37 measured tie accelerations only at Tie #10 at a distance of 6.1 meters (20 ft.) from the bridge
38 abutment also using piezo-electric accelerometers.
39

26 abutment shown in Figure 1(a). The Amtrak team placed eight (8) accelerometers on a single tie
27 with two of them on the rail seats at a distance of 6.1 m (20 ft.) from the abutment to focus on the
28 vibrational characteristics of this tie. The Amtrak accelerometer closest to the tie edge was used
29 for comparison because it best represents the tie location that was used by the UIUC team. The
30 vibrational characteristics of the ties were not analyzed for this paper but will be discussed in
31 future papers to investigate the damping characteristics of UTPs.

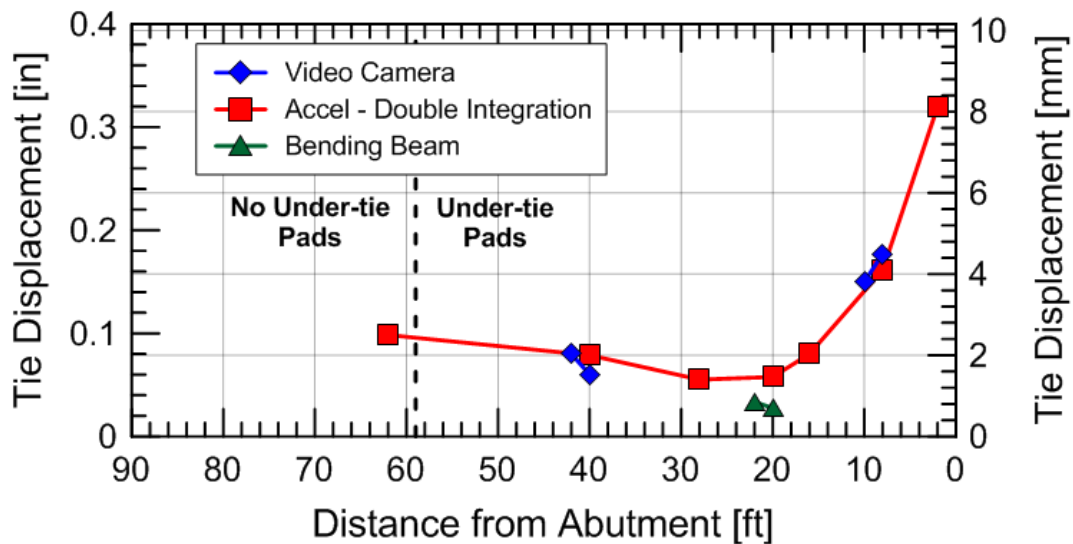
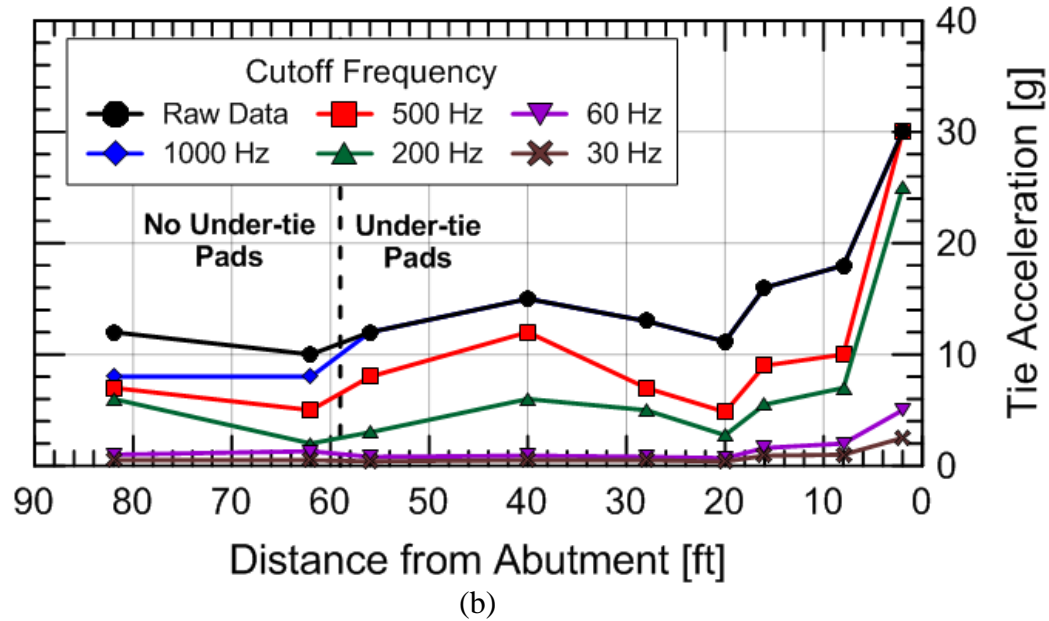
1 **Figure 6: Diagrams of: (a) peak displacement and (b) peak acceleration with distance from**
 2 **the abutment and (c) schematic of track support along the transition zone, which**
 3 **shows Ties #1 through #6 unsupported.**
 4

2 The peak displacement and acceleration values are plotted with distance from the abutment to
 3 evaluate changes in behavior along the transition zone for ties with and without UTPs. Figure
 4 6(a) compares the displacements from all available instruments and the displacement magnitudes
 5 show general agreement except for the lowest magnitude being from the Bending Beam
 6 displacement, which is probably due to vertical displacement of the reference crib ballast (see
 7 Figure 2(c)). In general, the results suggest large transient displacements near the bridge
 8 approach that decrease to a local minimum at about Tie #10 (20 ft.) and then slightly increase
 9 until the open track is reached.

10 Figure 6(b) shows the average peak accelerations at various frequency cutoffs. The
 11 general response agrees with the tie displacements, in which large accelerations are observed
 12 near the bridge abutment and the accelerations decrease until about Tie #10 (6.1 m) and then
 13 they increase again until the open track is reached. This increase in displacements with distance
 14 could be attributed to the “landing zone” for trains that ran southbound on Track #2 instead of
 15 the predominant direction of northbound. No significant difference is observed at the transition
 16 between ties with UTPs (Ties #1 through #29) and ties without UTPs (Tie #30+) but this is
 17 anticipated because all of the instrumented ties in the open track are well supported so the
 18 benefits of UTPs are not being manifested.

19 The displacement and acceleration results suggest that the first six to seven ties are
 20 unsupported with differing tie-ballast gaps as shown in Figure 6(c). This is in agreement with the
 21 impact observed at Tie #1 (2 ft.) in the tie acceleration response that was not observed at any
 22 other tie. The unsupported ties were also observed visually during train passage.
 23
